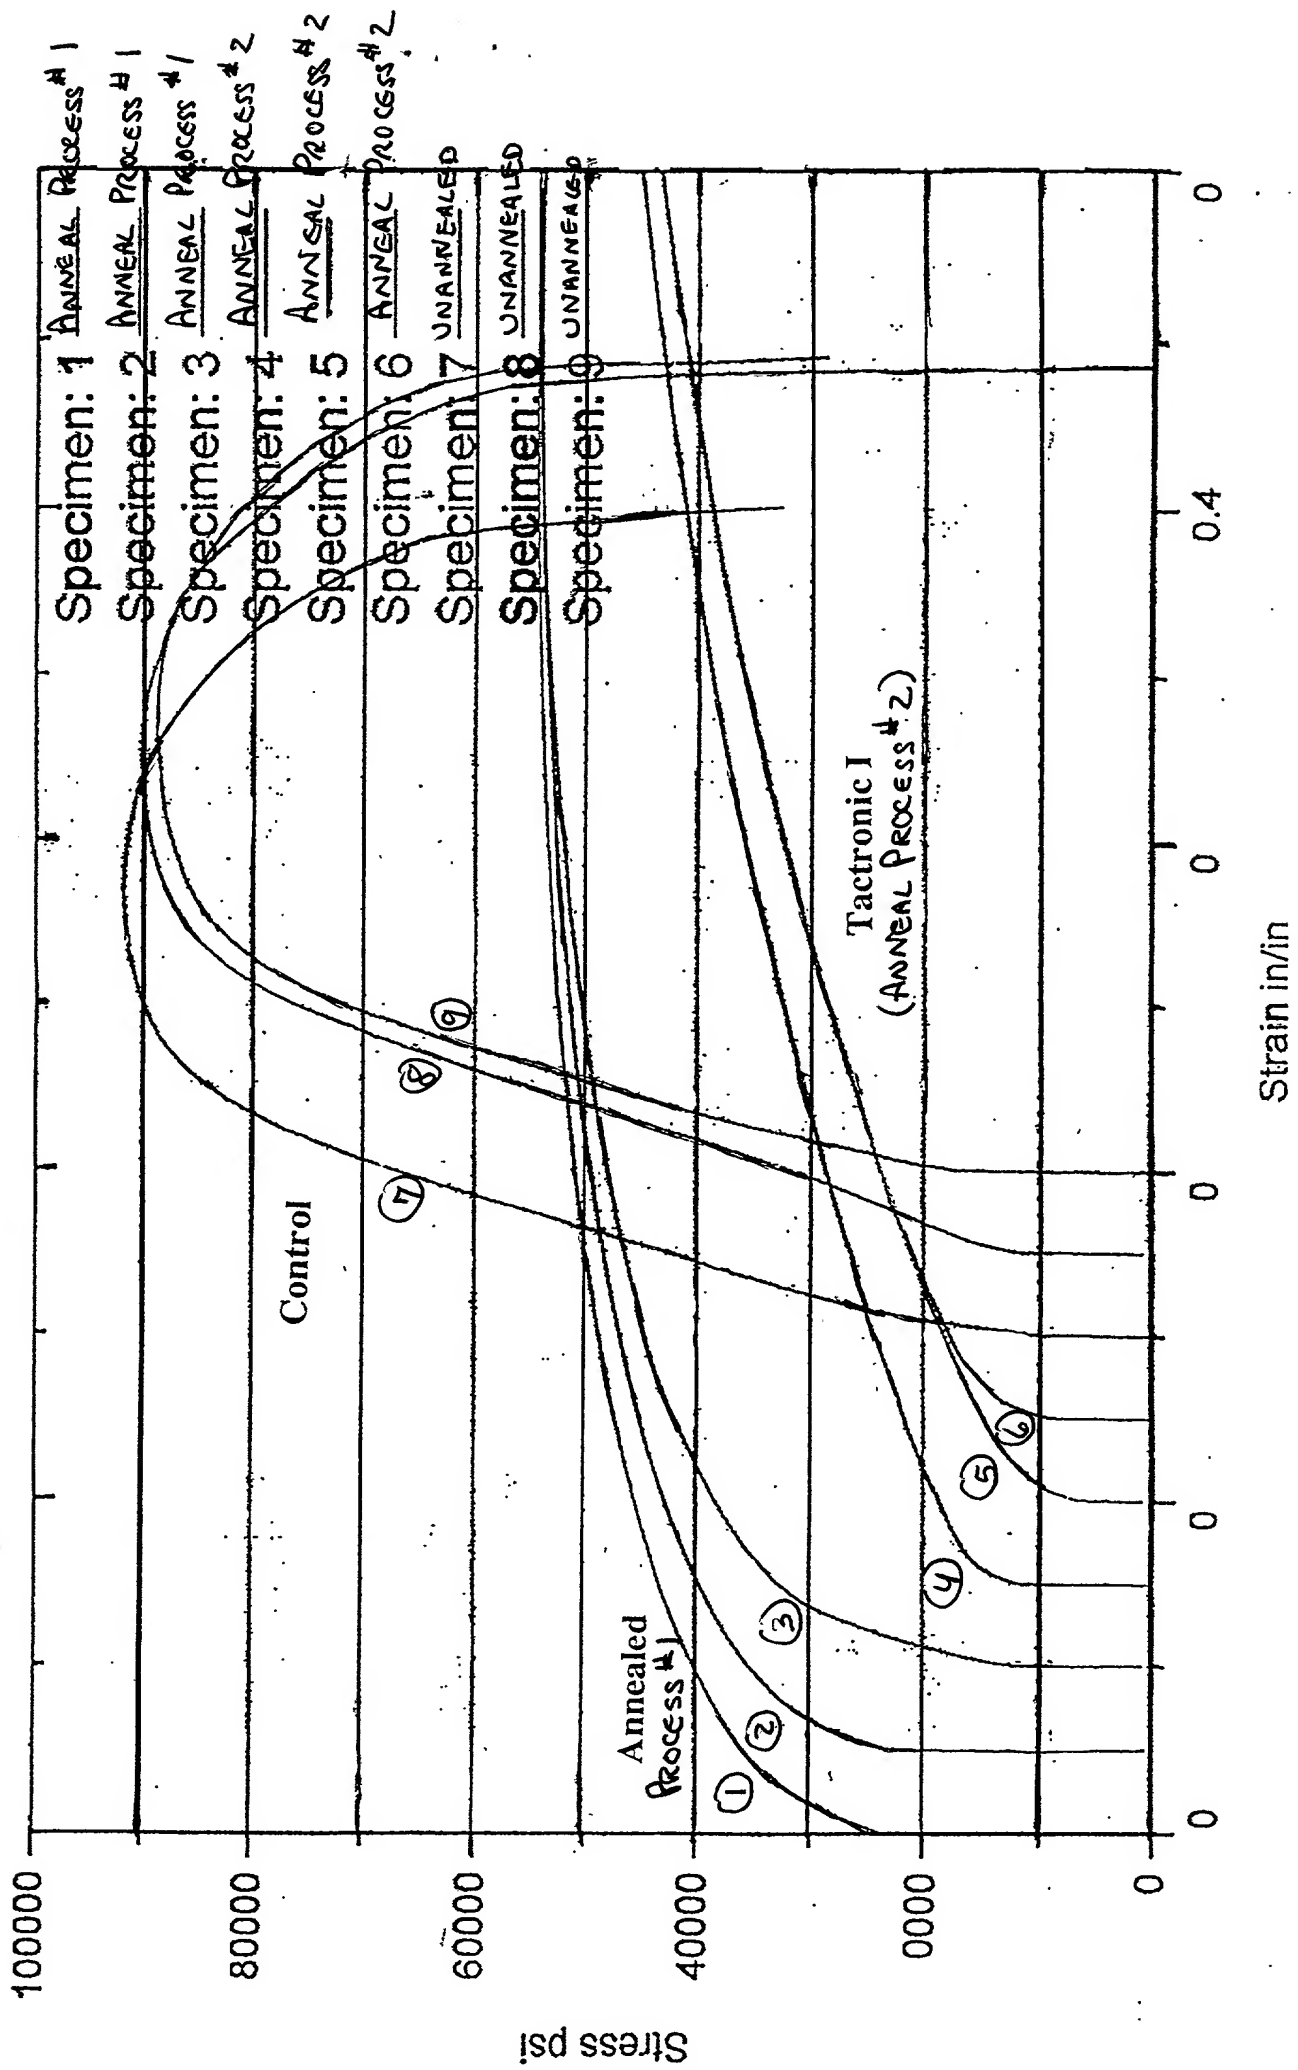
TESTED SPECIMENS FIG. 4

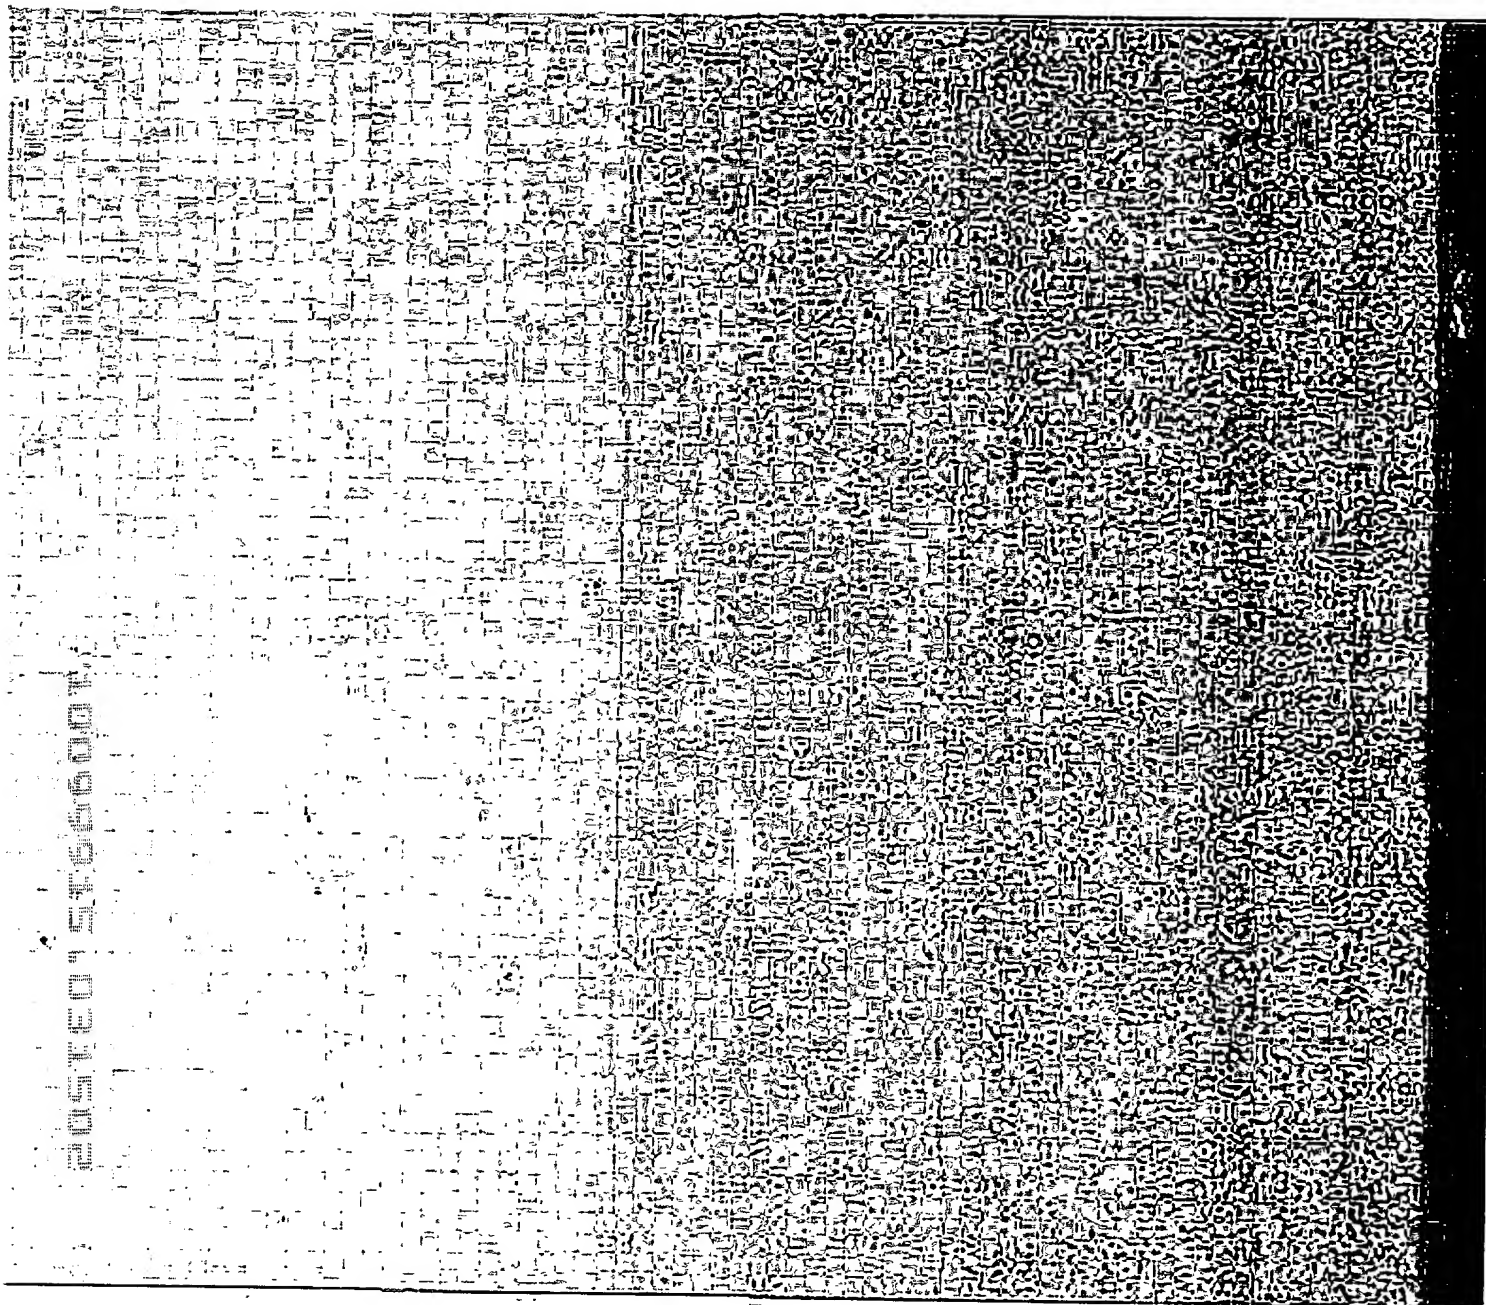
Figure 6 10% Sulfuric Acid Etch 100X
Annealed microstructure

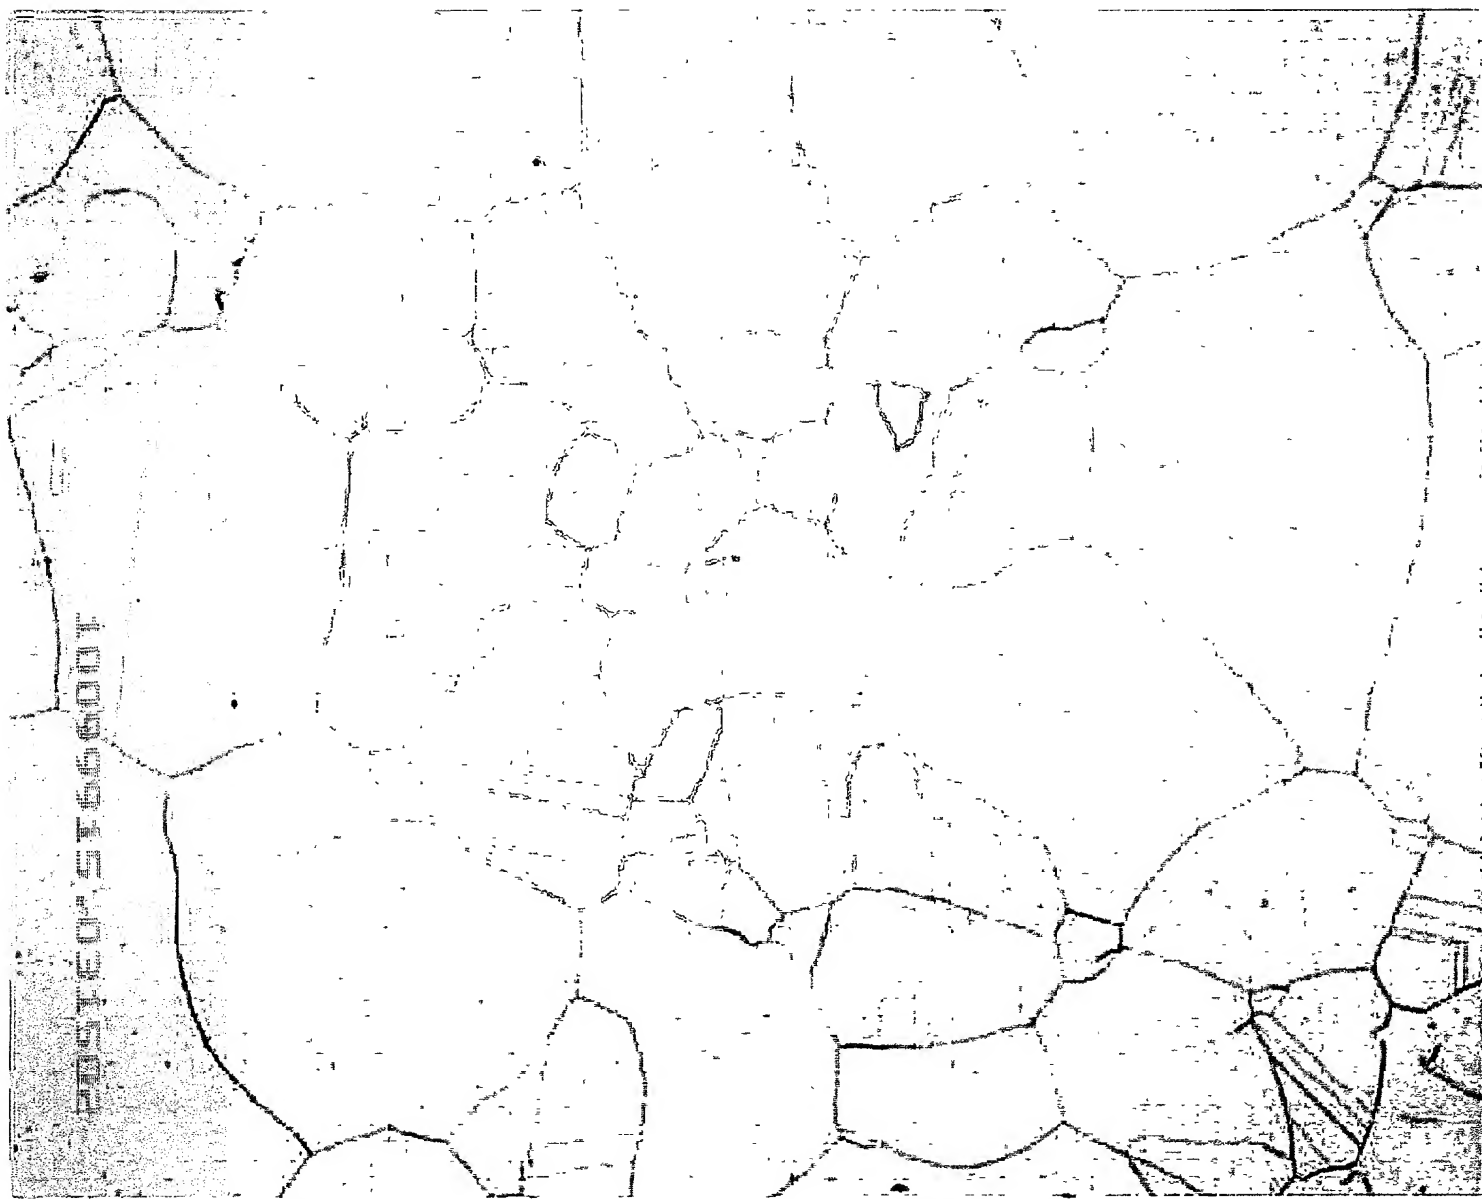
Figure 7 10% Sulfuric Acid Etch 100X
Annealed microstructure
